Clintwood Elementary School Facilities Condition Assessment Report

Dickenson County Public Schools

Prepared by OWPR, Architects and Engineers
200 Country Club Drive
Blacksburg, Virginia

Ervinton Elementary School Facilities Condition Assessment Report

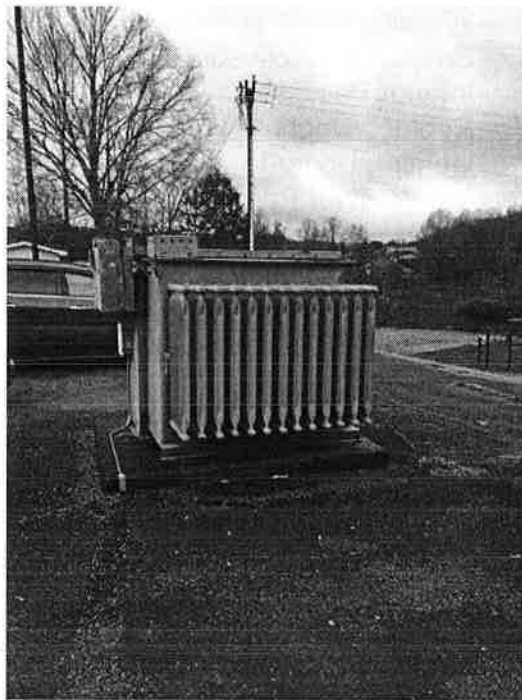
Generator

Electric: Electrical service is provided to the site via overhead electric lines and routed underground from a power pole near the service area to an adjacent transformer and into the building. The transformer is old and rusted, but functional and is not protected from traffic. The generator is in good condition, but is not protected from traffic.

- Recommendation (5 year): Provide bollards to protect the transformer and generator from traffic.
- Recommendation (10 year): No action

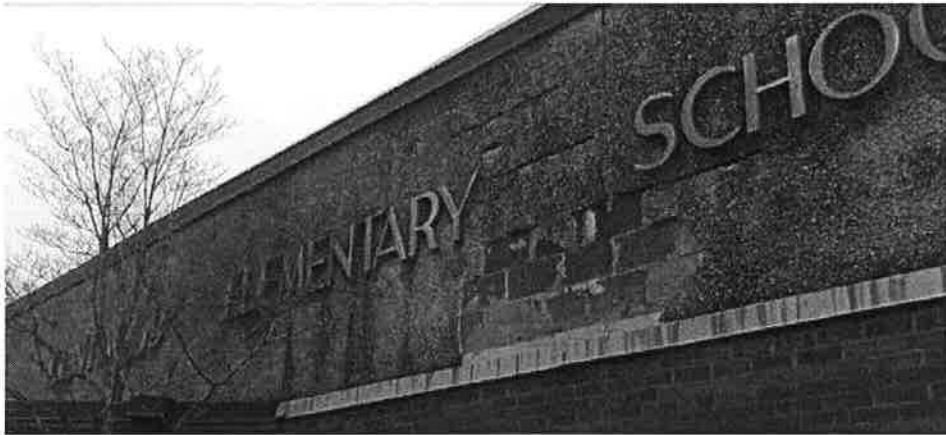
Exterior: The exterior wall material is predominantly brick. Brick was observed to be in good condition. At the top of the exterior walls, a pebble aggregate faced panel transitions the brick to the roof edge. These panels are in poor condition and are delaminating.

Damaged façade panels at front of school

- Recommendation (5 Year): Replace pebble aggregate faced panels with new pre-finished aluminum panels on furring channels.
- Recommendation (10 year): No action

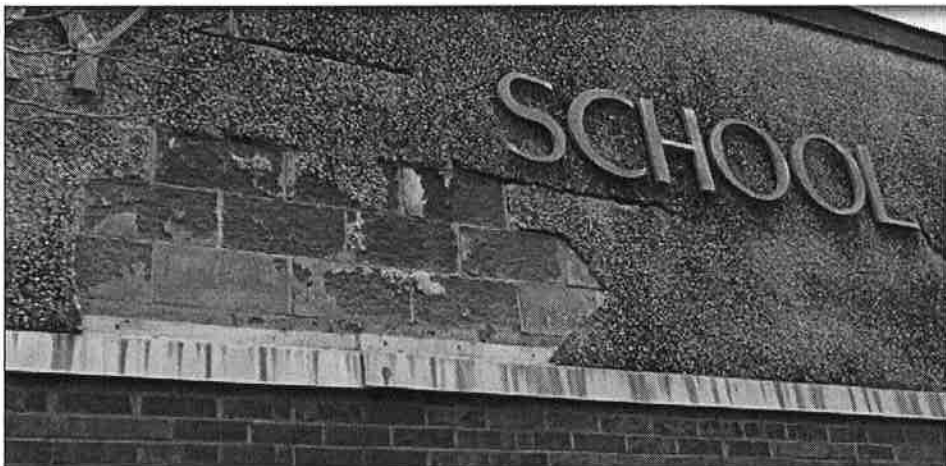
Exposed cmu at damaged façade panels

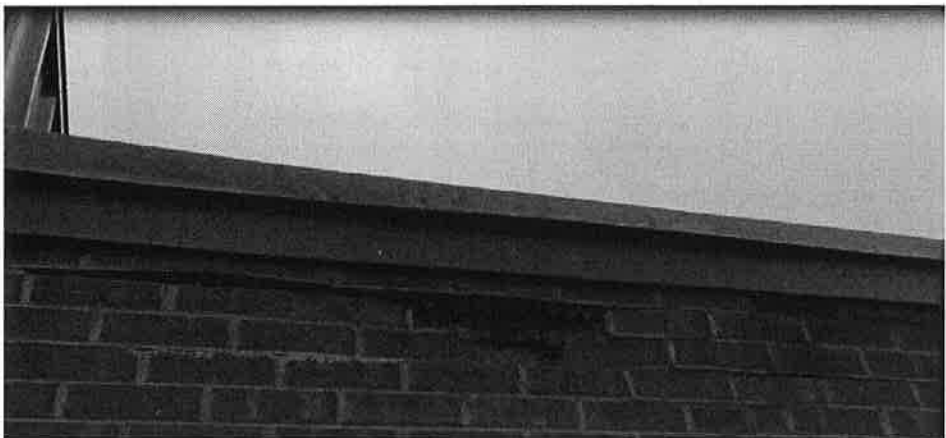
Damaged brick at roof

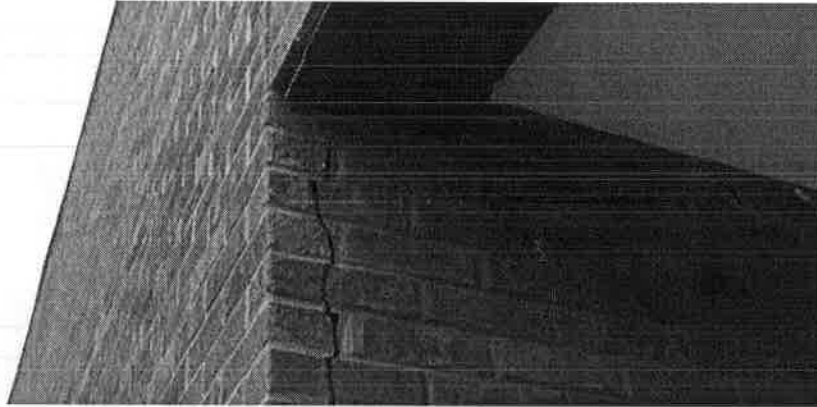
There are some structural issues in the building. On the exterior of the building, there are several areas where the brick façade has cracked, and the brick have moved out of alignment. This is likely a combined result of no control joints in the brick and a possible roof/parapet leak that has allowed water to get behind the brick and freeze. There are also some cmu cracks within the building. The floor settlement adjacent to the Kitchen was discussed earlier in the report, along with a recommendation.

Crack in brick at lintel

- Recommendation (5 year): Repair the brick on the façade and add a control joint in this general location. The roof replacement should address any water getting behind the brick. Monitor the cmu cracks on the inside of the building and if they appear to get larger, a structural engineer should further investigate.
- Recommendation (10 year): Monitor building façade and interior cmu for further cracks.

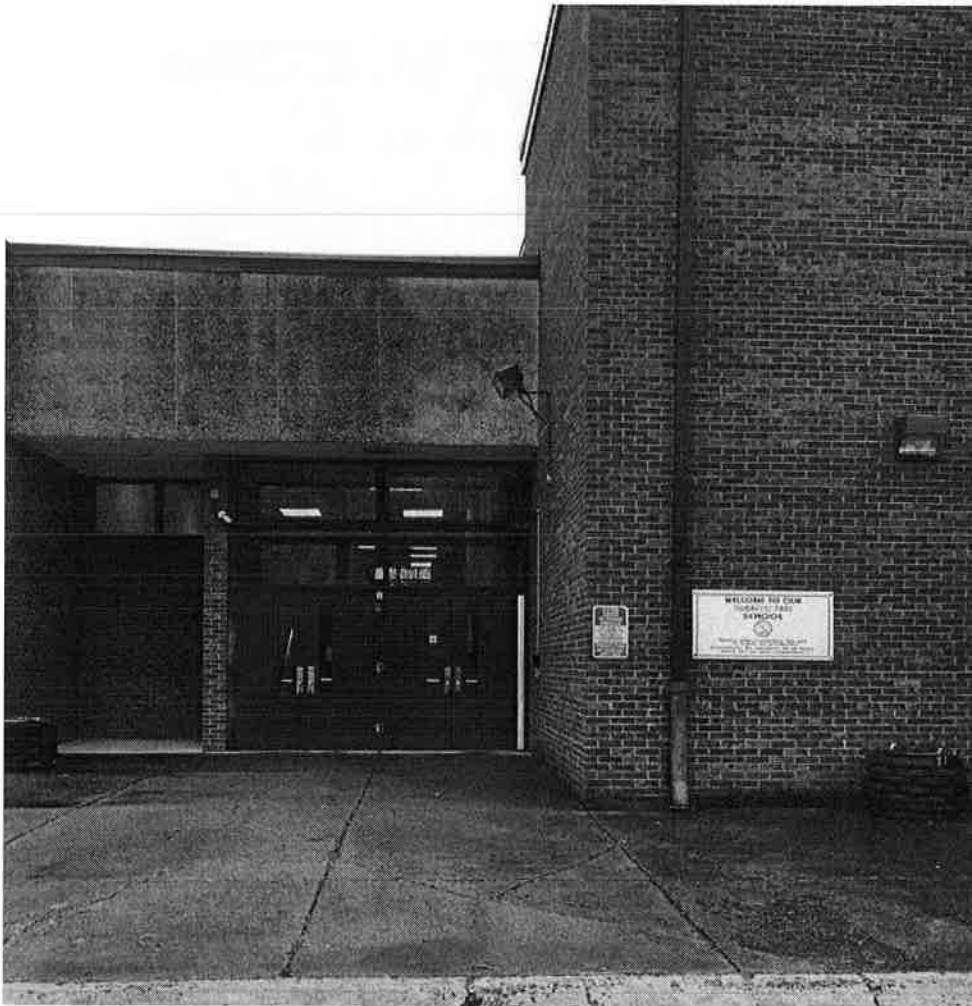
Worn façade panels at entrance

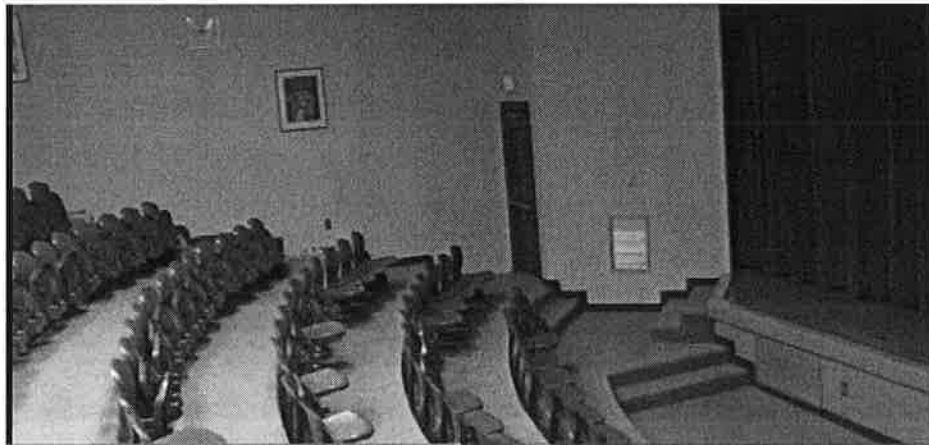
Multi-tiered auditorium not ADA accessible at stage

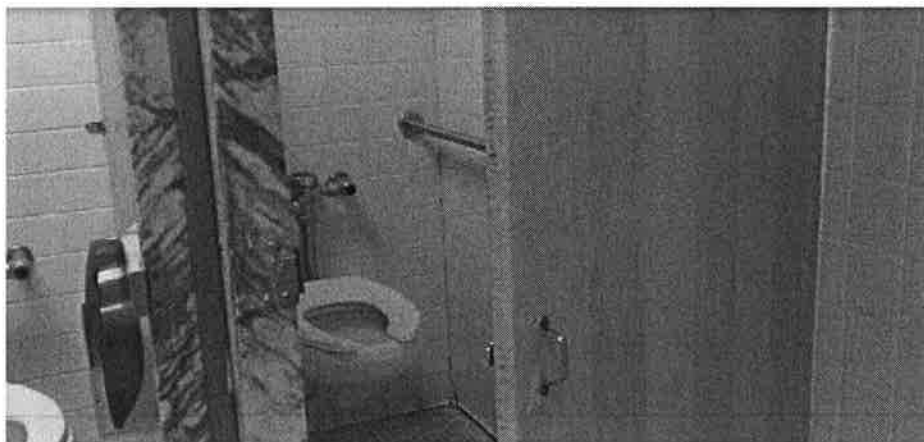
Restroom adapted for handicap use does not meet current standards
